4.0 CAMERA UNIT SETUPS

4.3 FIELD INSPECTION RESULTS

San Diego Photo Enforcement System Review

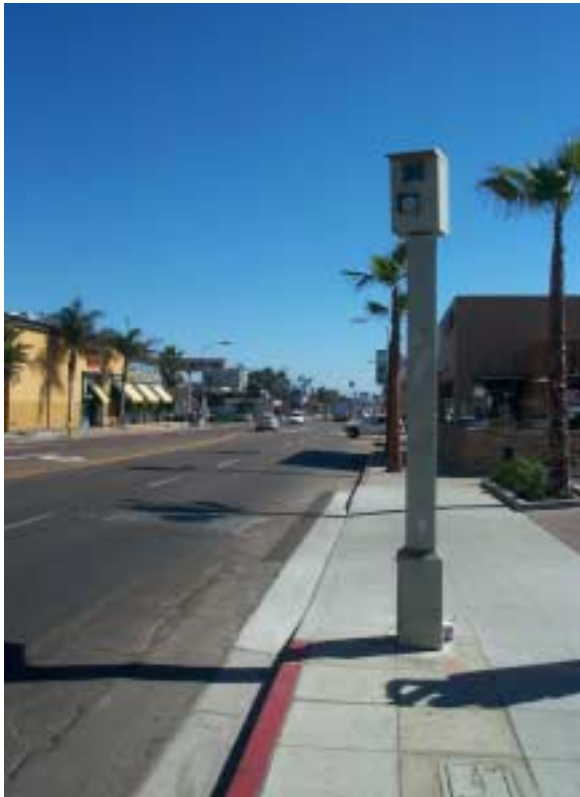
Figure 4-1
CAMERA POLE AND HOUSING

The camera pole (See Figure 4-1) and housing (See Figure 4-2) were visually examined to determine the type and condition of the unit. In addition, the pole model was obtained from the LM/ACS representative.

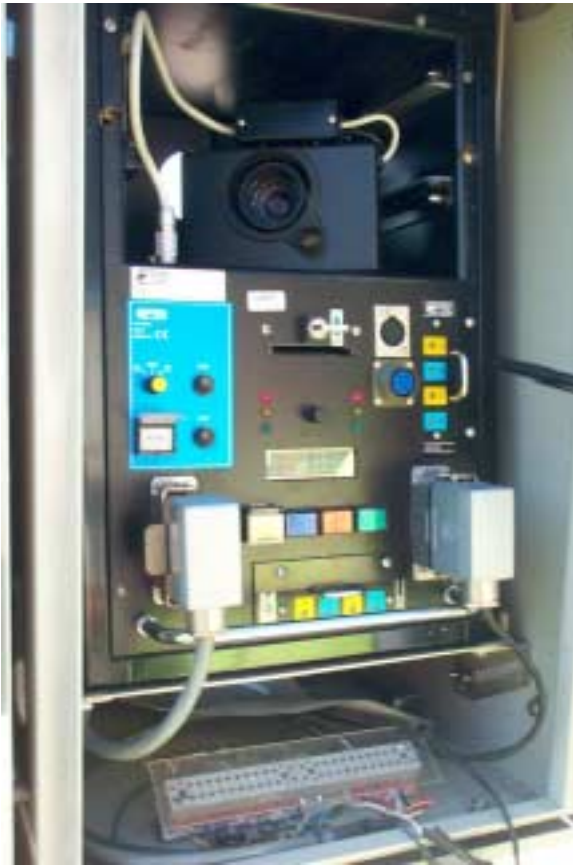
Figure 4-3
INSIDE VIEW OF CAMERA HOUSING
SHOWING CAMERA UNIT

The external information and settings on the camera unit were visually observed, verified and recorded. Information was obtained shortly after the camera unit housing was opened and before any alterations were made to the camera unit. Intervention of the LM/ACS representative was needed to obtain the camera lens information (e.g. aperture, focal length, and filters). In the process of obtaining this information, the camera unit installed within the camera unit was removed, and settings were shown to the PBF representative. The type of information that was recorded is provided below. The inside of the camera unit and camera are shown in Figure 4-3.

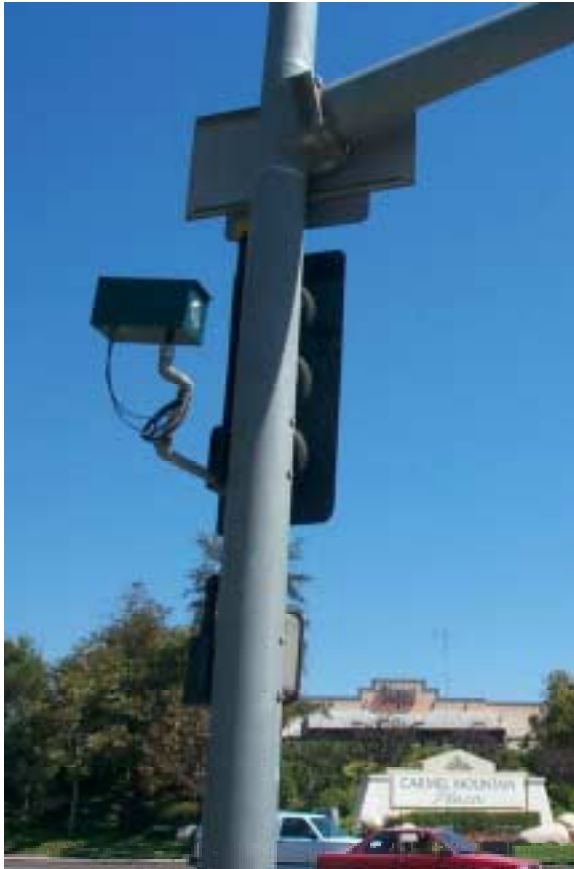
Figure 4-6
EL 250 AUXILIARY FLASH

An auxiliary flash(s) were installed at eight locations to help illuminate the interior cabin of the vehicle committing a red light violation (see Table 4-10). Auxiliary flashes were not installed at the other eleven intersections because either they were not needed or the intersection geometry prevented the installation of units at locations close enough to the intersection where the flash would be beneficial. In most instances, the EL 250 (250 indicates the flash's intensity in watts) model flash was used (see Figure 4-6). The exception would be the intersection of Aero Drive at Murphy Canyon Road where the EL 500 model flash was used (see Figure 4-7).

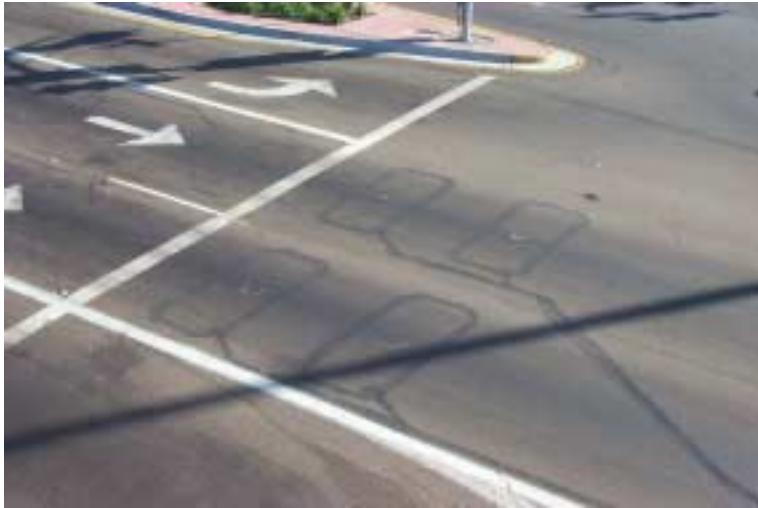
**Figure 4-8
TYPICAL LOOP
ARRANGEMENT**

Loop detectors are installed at each photo-enforced intersection to detect vehicles that commit a red light violation and enable the camera unit to take two pictures of the vehicle as it traverses the intersection. At all but one of the photo-enforced intersections ("A" Street at 10th Avenue), loop detectors were placed on the intersection side of the approach stop bar. If a stop bar is not present for a monitored intersection approach, the crosswalk striping was used. Each lane that is enforced has one pair of loop detectors.

Figure 4-8, illustrates the typical placement of loop detectors.
